# **REMUERA**

## **RAILWAY STATION + SIGNAL BOX**

57-58 Market Rd/122 Great South Rd, Remuera

## **CONSERVATION PLAN**

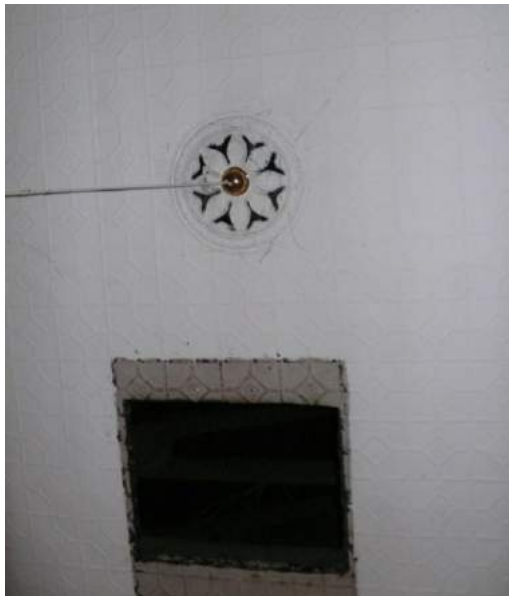
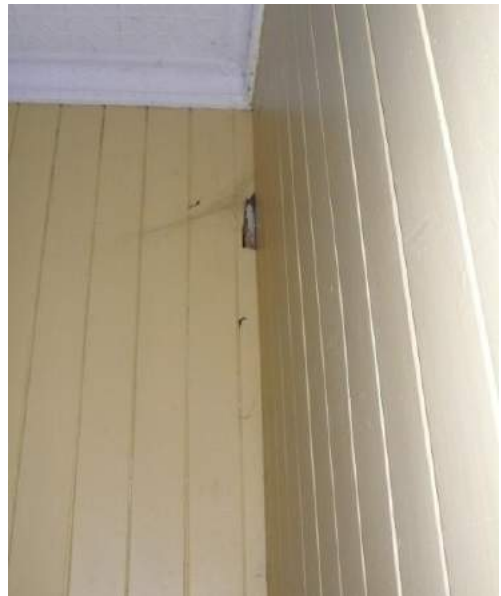
Ceiling rose + hole cut into pressed metal ceiling (left) Damage to t & g wall lining, Images: B, T & K Architects 2015

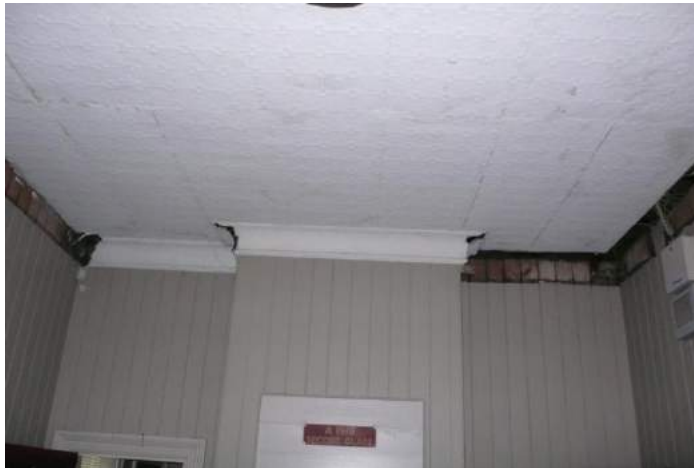
Showing south wall, ceiling with sections of missing cornice (left) missing pressed metal cornice

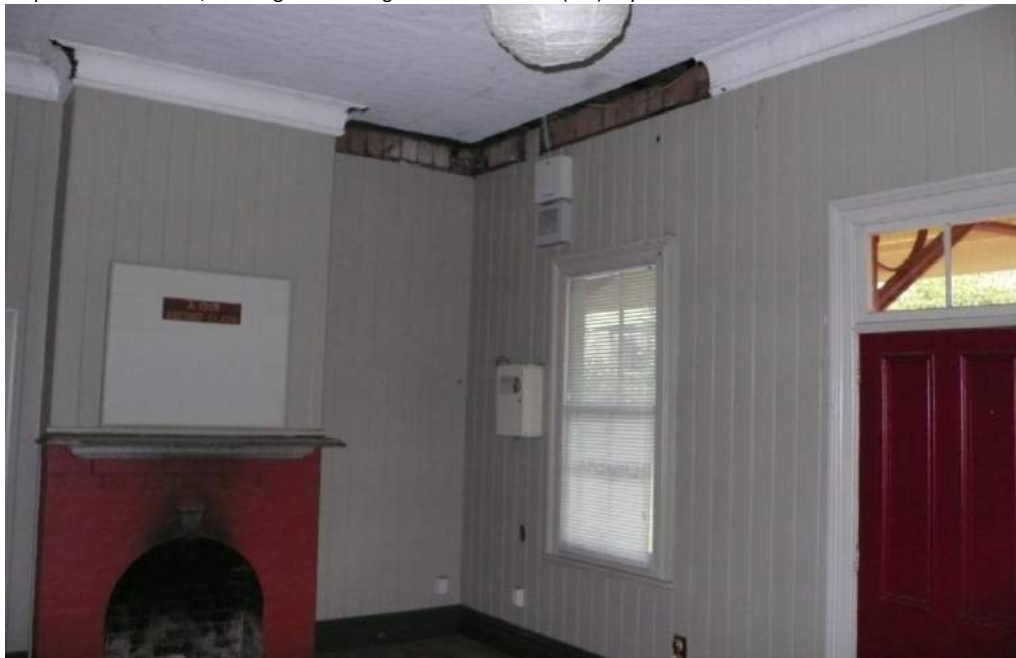
South west corner of the Station master & Booking Office, note large section of cornice missing, Images: B, T & K Architects 2015

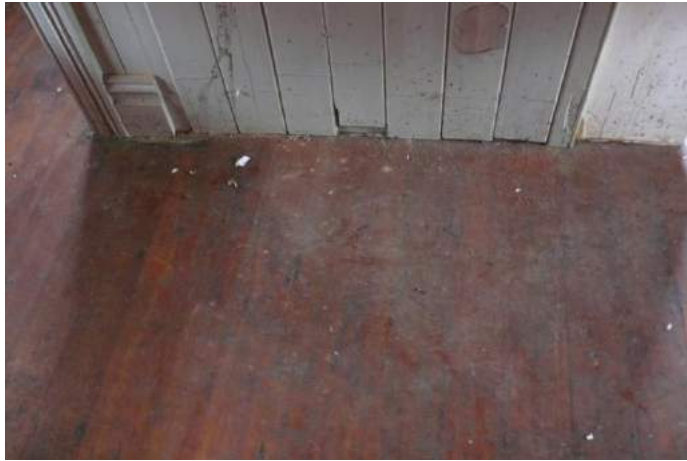
Section of missing skirting board (left) Distribution board on west wall, note hole in t & g lining

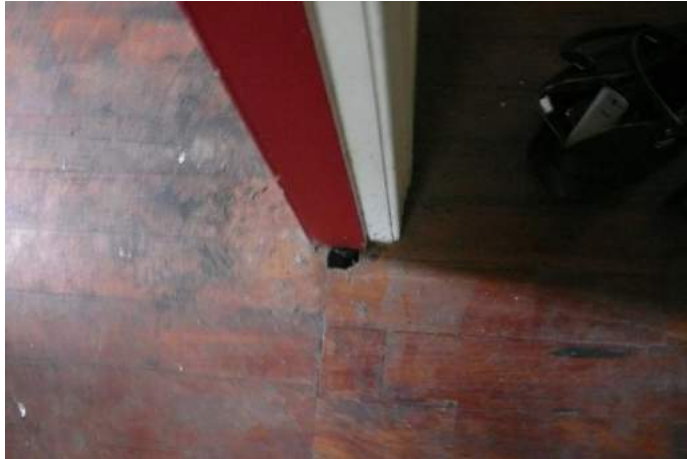
Hole in floor at doorway (left) new doorway into evidence in floorboards of where wall previously ran through

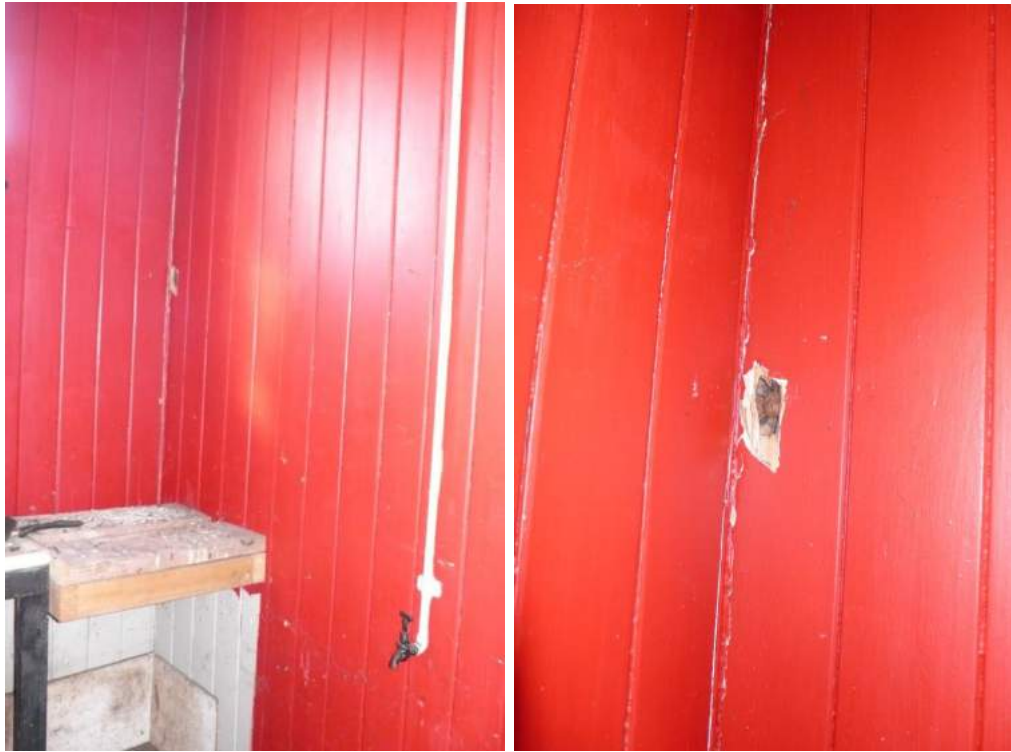
Showing north east corner of kitchen area + wall mounted tap (left) damage to t & g wall lining

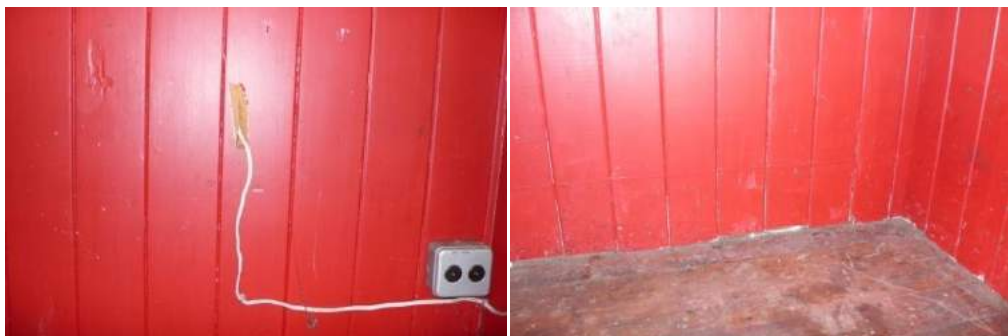
Exposed wiring (left) missing skirting board in kitchen

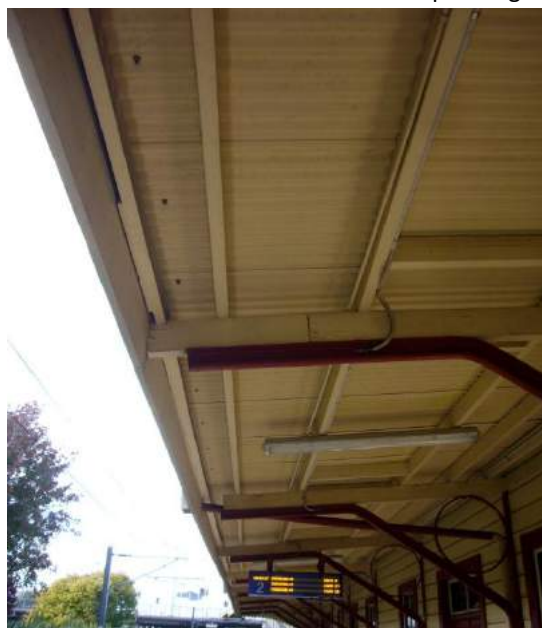
The verandah roofing was replaced in 1996. The flashing between the roof and the wall has not been properly fixed. This is loose on the southern side and this intersection has been leaking. Daylight can be seen from below. Two horizontal bars have been fitted along the verandah roof as safety markers following electrification. These elements affect the flow of water down the roof. These roofs need a full clean down and painting.

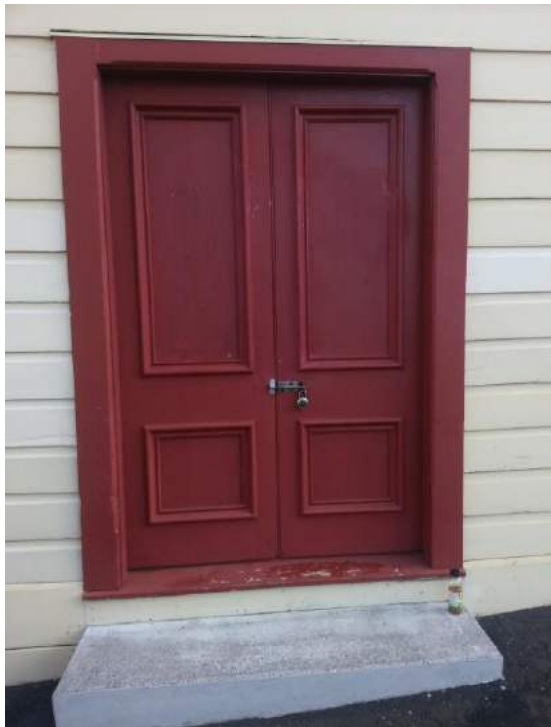
The doors have not been fully repaired. Many of the rails are damaged, some by general use and this may be considered as ‘patina’. The panelling on some doors is split and broken and all the lock/hardware areas are heavily damaged.

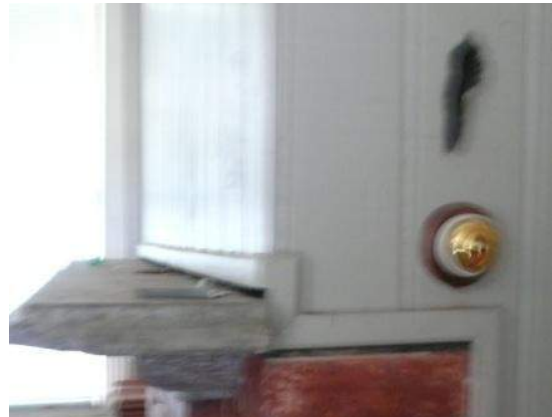
There is also some evidence of borer damage (also noted in the 1992 plan).

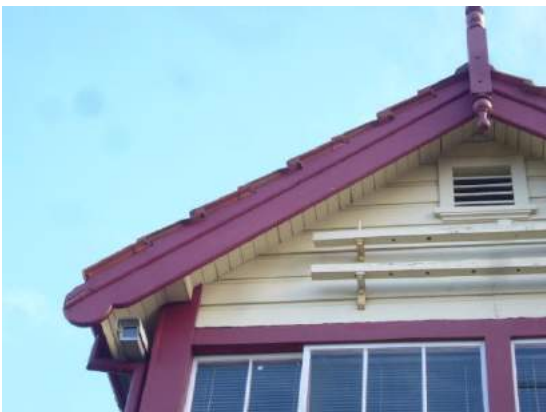
| <b>SOFFITS</b> | The soffit is narrow tongue & groove board. In several areas it is badly damaged. There is a large hole in the soffit at the north western corner of the entry porch gable. At the north west corner of the main roof the fascia is pulled away from the soffit, and nesting material has spilled out of the gap. The nesting material has been painted to match indicating that this problem is long |
