# **REMUERA**

## **RAILWAY STATION + SIGNAL BOX**

57-58 Market Rd/122 Great South Rd, Remuera

## **CONSERVATION PLAN**

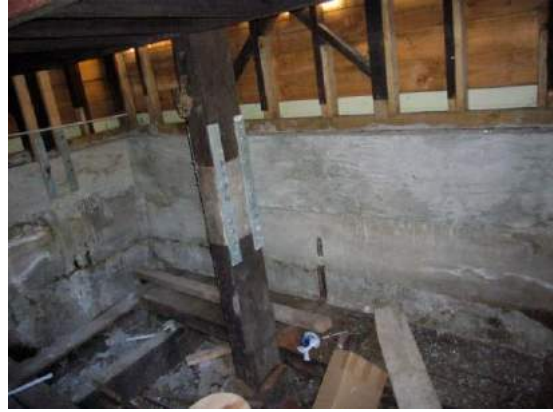
A new concrete foundation wall has been constructed on top of the original foundation wall up to ground level. The original bottom plate has been replaced. Before this change, the box apparently used to rock when the levers were operated.

Subfloor of the signal box, Image: B, T & K Architects 2015.

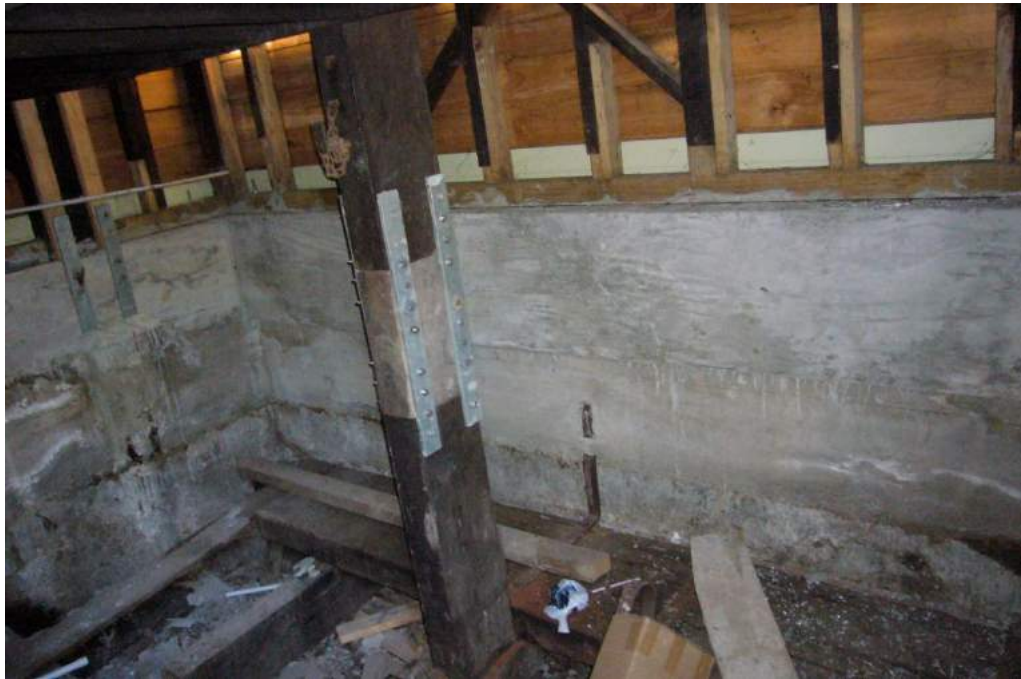
Floor joists to the station are 125 x 50 mm fixed to 100 x 100 bearers on top of timber piles, with a stringer bolt fixed to the exterior foundation wall. The entire subfloor of the station and signal box was fully replaced in 2010.

Subfloor of the signal box, Image: B, T & K Architects 2015.

The lower level of the signal box has a 100 x 75 mm framing. The original bottom plate was 200 x 100 mm fixed to a concrete foundation wall. The plate was removed when a new wall was poured on top of the old wall up to ground level. Remaining original timber in contact with the ground or below ground level appears to have been creosoted as a protection against decay. All this area of the signal box structure has been upgraded.

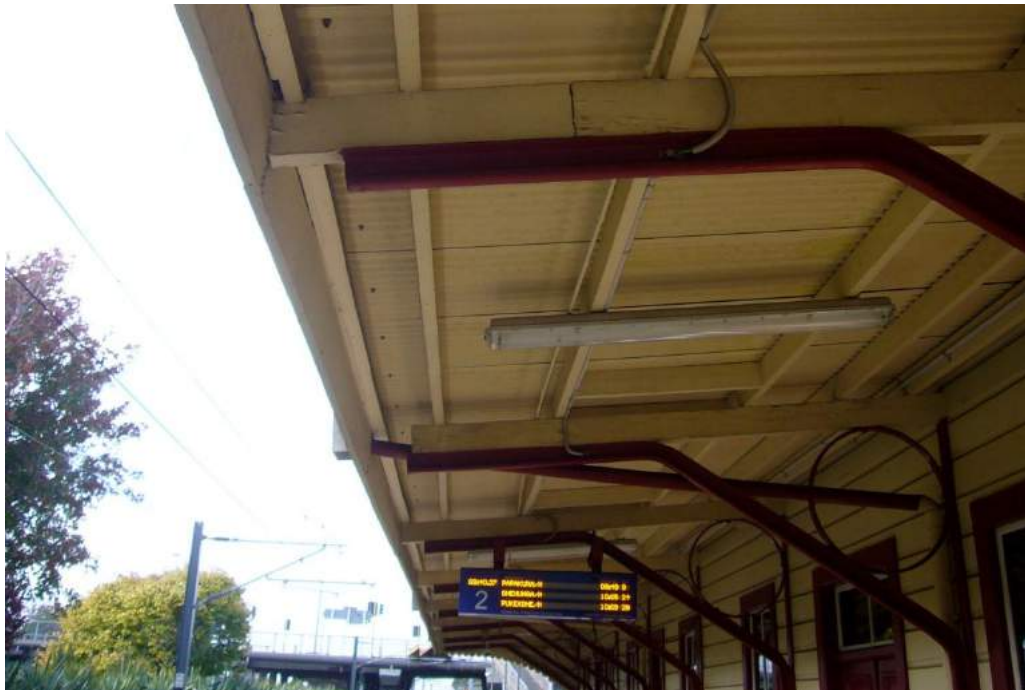
The roof as previously described is corrugated iron. Originally there were skylights built into these roofs. The framing of these remains in place.

Showing the underside of the station verandah roof, Image: B, T & K Architects 2015.

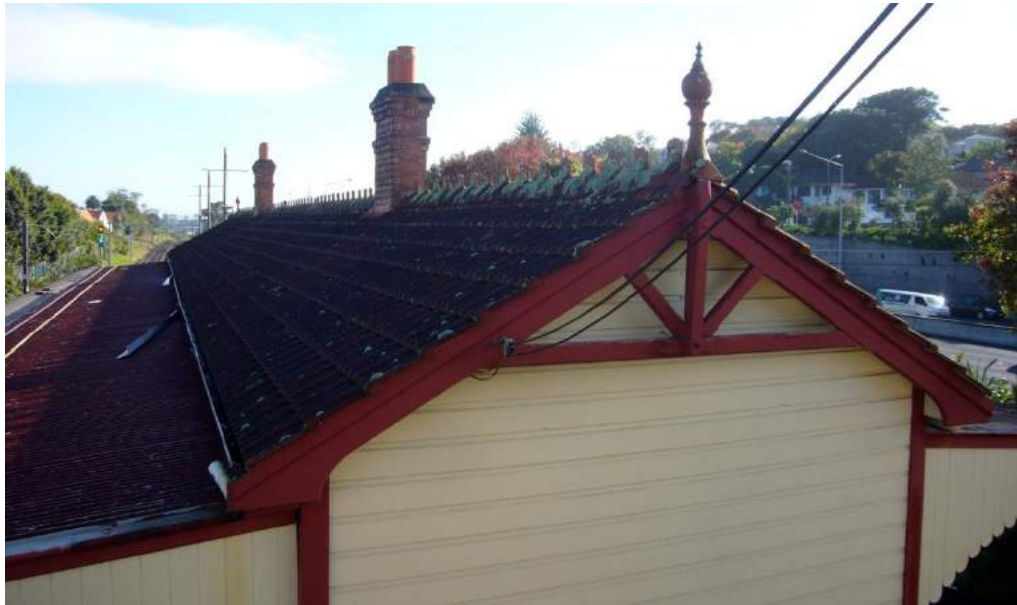
The station has two corbelled brick chimneys. Neither chimney has the original glazed chimney pots. These are clearly shown in the photographs in the measured drawing assignment in the Architecture School Library.

Roof of the Station Building, Image: B, T & K Architects 2015.

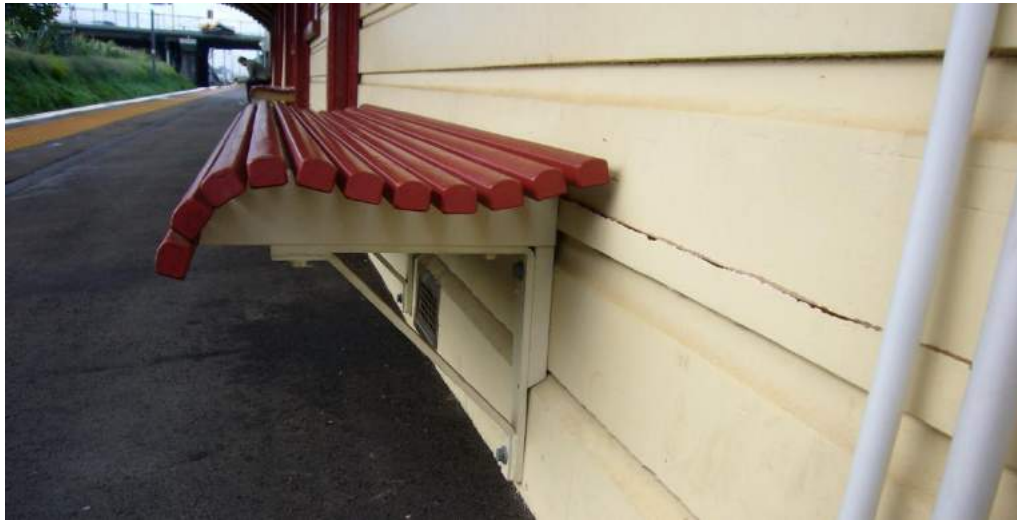
Timber slatted seats, Image: B, T & K Architects 2015.

Three timber slatted seats were fitted to each of the two principal elevations. One of these has been removed but is stored inside the building. The metal fixing brackets have been shifted at some stage and do not connect to solid structure. As a result the seats are causing damage to the cladding.

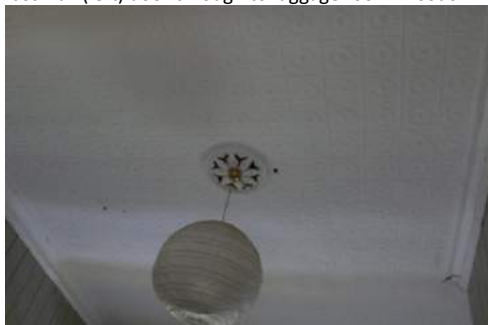
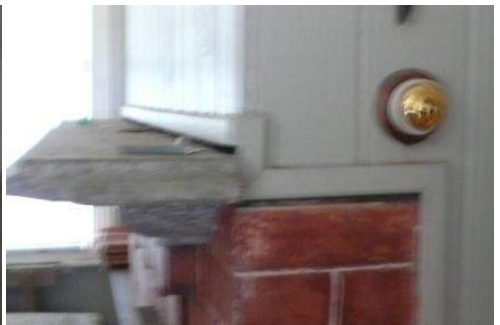
Pressed tin ceiling (left) showing concrete mantle pulling away from wall, Images: B, T & K Architects 2015

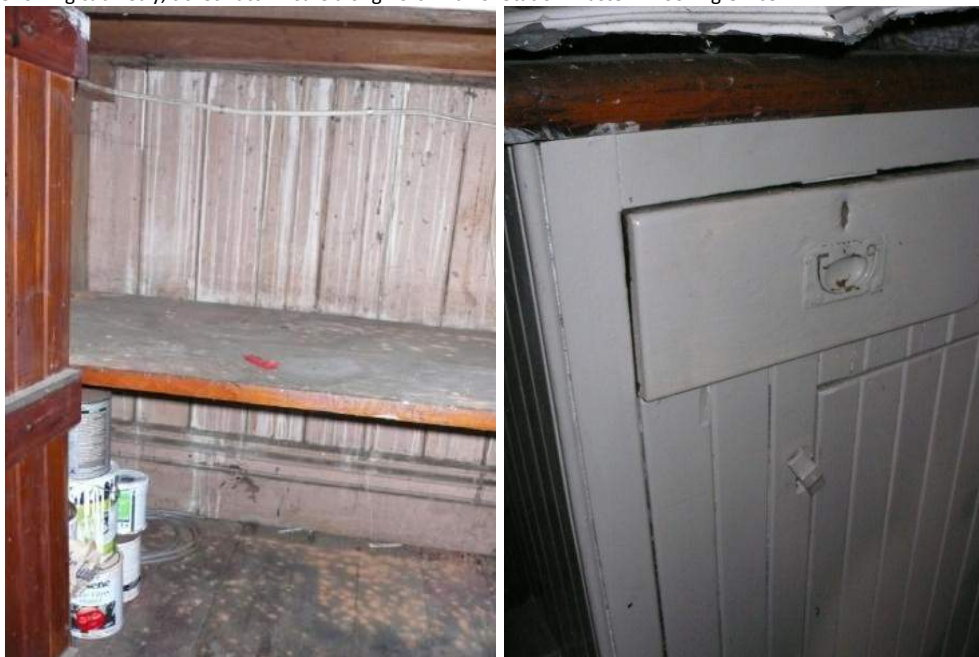
Showing t & g lining to interior of cabinet + evidence of borer (left) cabinetry detail, lockable drawer, Images: B, T & K Architects 2015

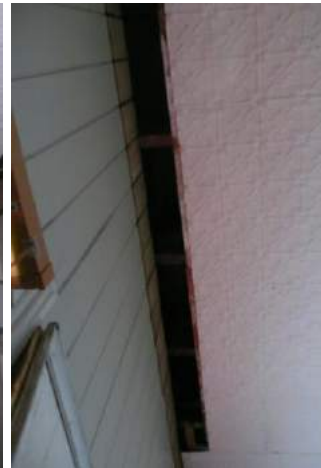
Showing south wall, ceiling with sections of missing cornice (left) missing pressed metal cornice

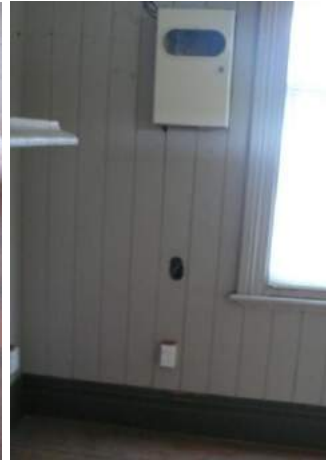
Section of missing skirting board (left) Distribution board on west wall, note hole in t & g lining

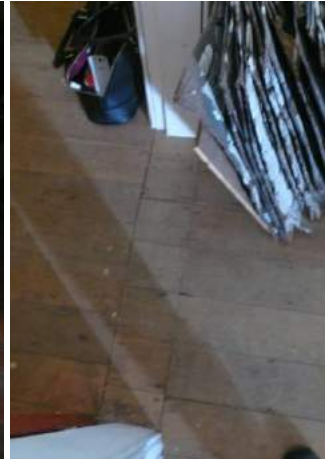
Hole in floor at doorway (left) new doorway into evidence in floorboards of where wall previously ran through

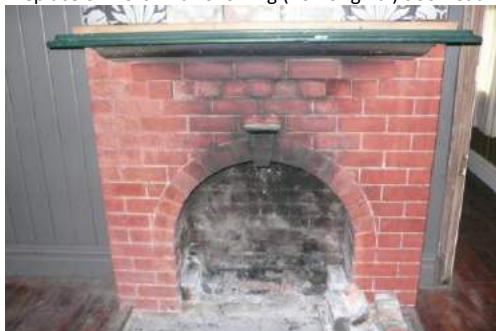
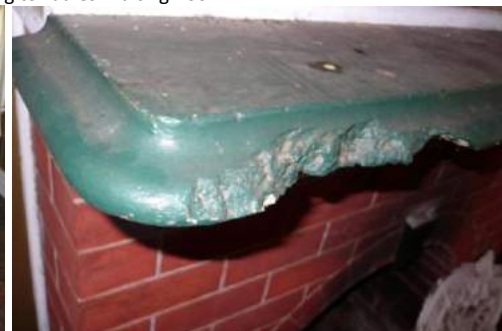
Fireplace on north wall (left) close up of damage to edge of concrete mantle, Images: B, T & K Architects 2015

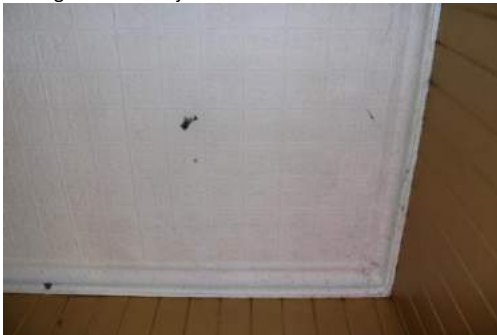
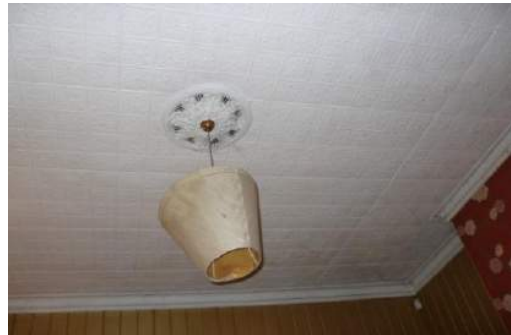
Damage to pressed tin ceiling tiles (left) ceiling rose

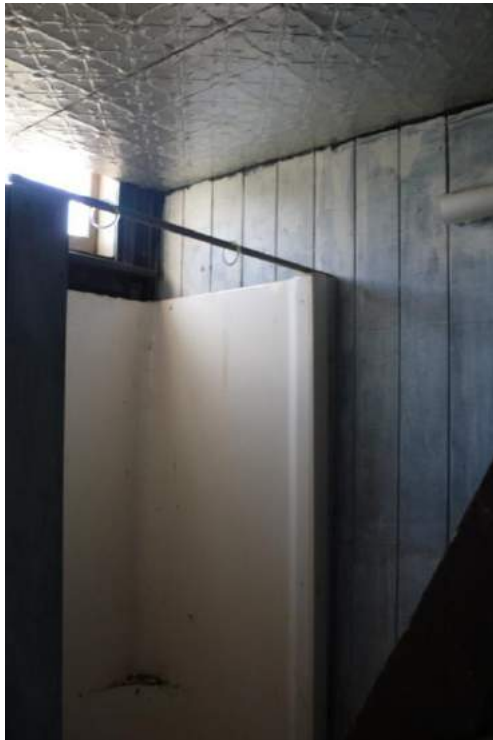
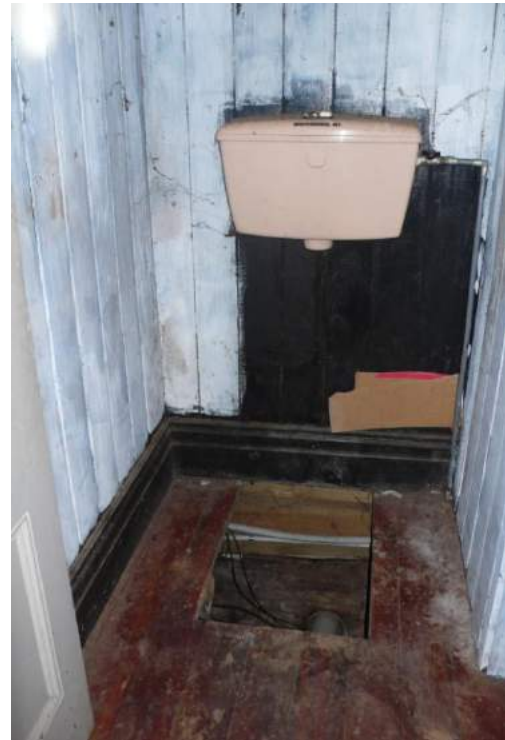
Showing shower unit fitted to existing toilet cubicle (left) hole in floor where toilet has been removed

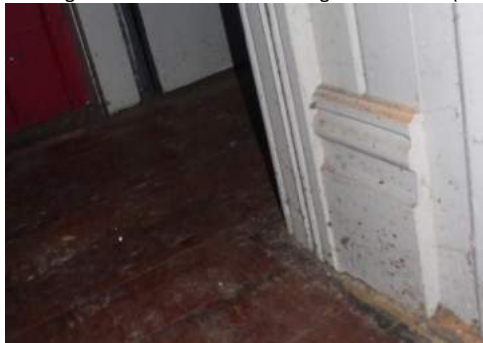
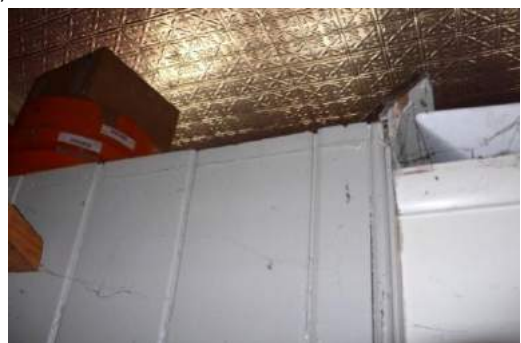
Toilet partition wall, section of skirting missing (left) section of cornice missing, Images: B, T & K Architects 2015

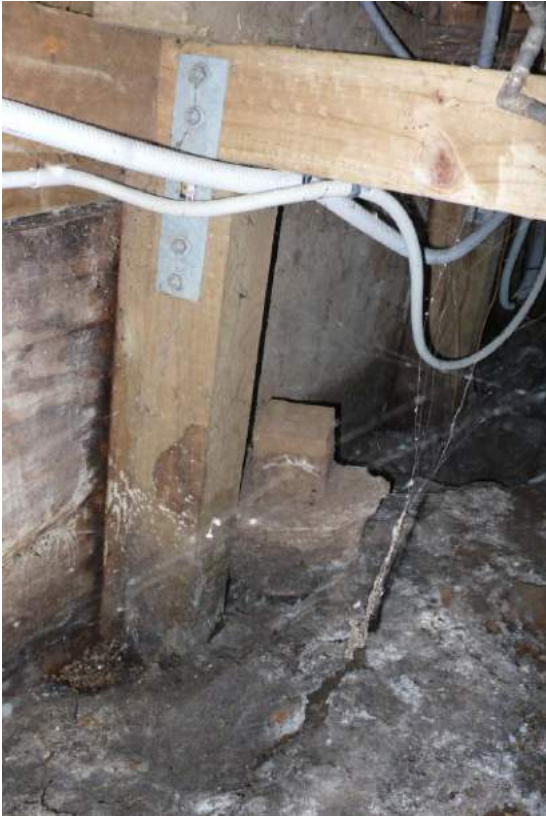
| <b><u>ELEMENT</u></b> | <b><u>CONDITION / ACTION REQUIRED</u></b> |
|---|---|
| <b>TIMBER FRAMING</b> | <p>The timber framing is in very good condition. The foundations were replaced in 2011 during the building lift and other repairs were possibly carried out by NZ Rail at that time.</p> |
| <b>ELECTRICAL SERVICES</b> | <p>The building has been re-wired by the Trust. Check the electrical services. 3 conduits have been fitted up the wall at the northern end of the eastern side of the building. These detract from the appearance of the building.</p> |

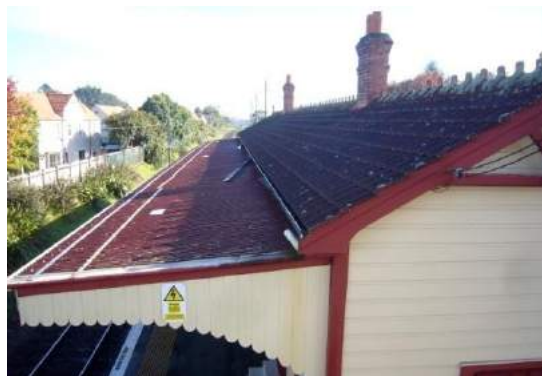
| <b>GABLED MAIN ROOF</b> | |

Marseilles tiles, crenellated ridging, terminals  
Roof Repaired in 1996. New terracotta finials installed. The roof is in reasonable condition but has lichen growth and needs cleaning and checking.

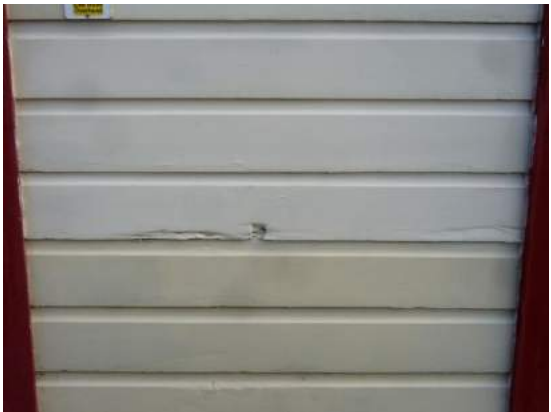
| <b><u>ELEMENT</u></b> | <b><u>CONDITION / ACTION REQUIRED</u></b> |
|---|---|
| <b>WEATHERBOARDS</b> | <p>Mr Pearson noted many defects in the cladding. A lot of work has been carried out on the exterior of the building since 1995. There are few visible defects.</p> <p>Where the seat brackets have been fitted along the northern and southern sides of the building the weatherboards have split and cracked as the brackets are not fitted to structure they are hung on the weatherboards and have caused substantial damage.</p> <p>Horizontal base boards have been fitted around the building at the platform level following the lift of the structure. (Refer platform notes)</p> |

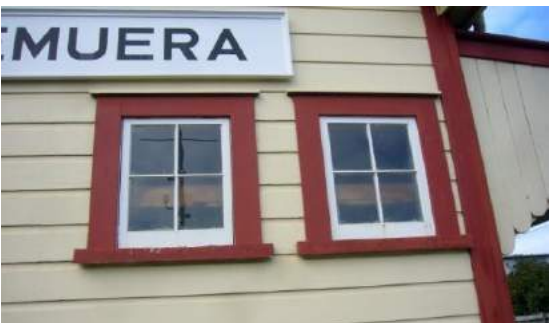
| <b>WINDOWS</b> | <p>The windows have all been repaired since 1995. Check all windows + window hardware.</p> |

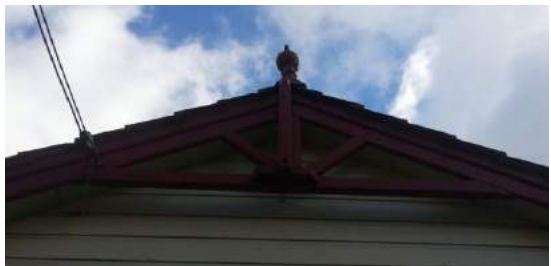
**EXPOSED GABLE TRUSS- EACH END**

Good condition

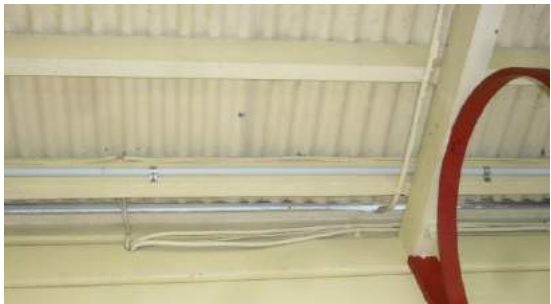
**EXPOSED VERANDAH ROOF STRUCTURE**

Exposed timber framing is in a reasonable condition. Check all timbers and repair as required.

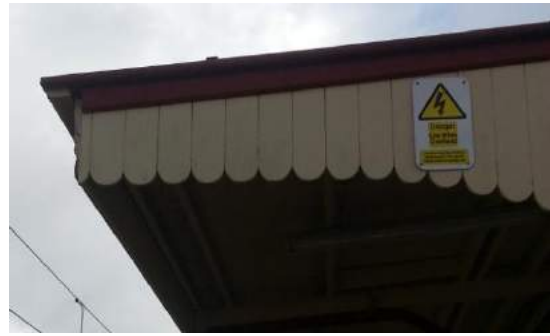
#### **VALANCING TO VERANDAH**

Valance boards broken at the northern end of the eastern platform. Repair/replace to match detail and profile.

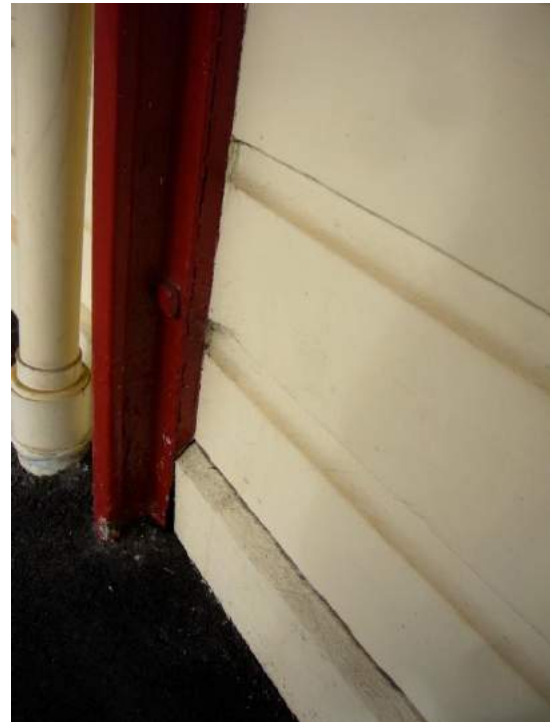
#### **CANOPY STANCHIONS**

Good condition

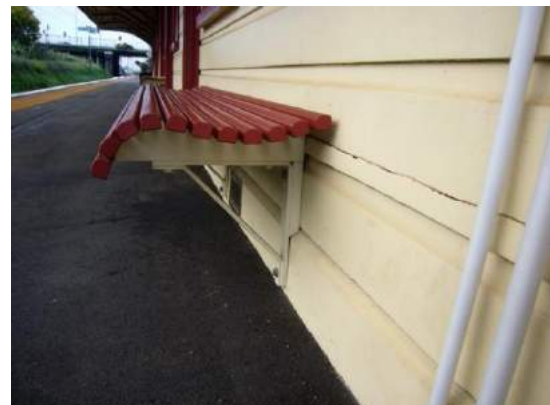
#### **SEATS**

The seat support bracket system is causing damage to the cladding. The seats are in good condition.

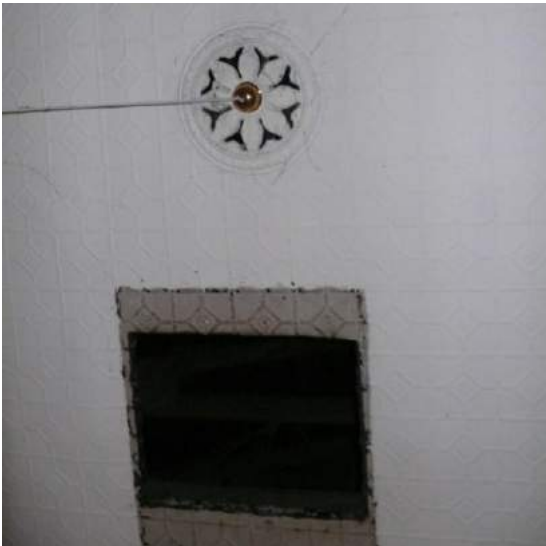
**CEILING & CORNICE**

Ceiling in poor condition with sections missing and extensive rust evident.

Large access hole cut into ceiling above double doors on south wall

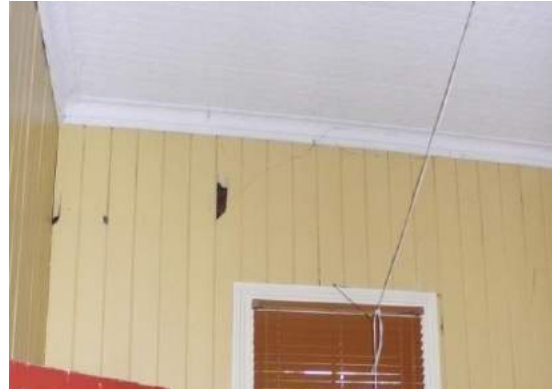
Vertical tongue and groove wall linings are in generally reasonable condition although there are several large holes + split boards (location of damage indicated on plans)

Hole in south wall covered by metal plate (evidence of location of basin which has been removed since 1992)

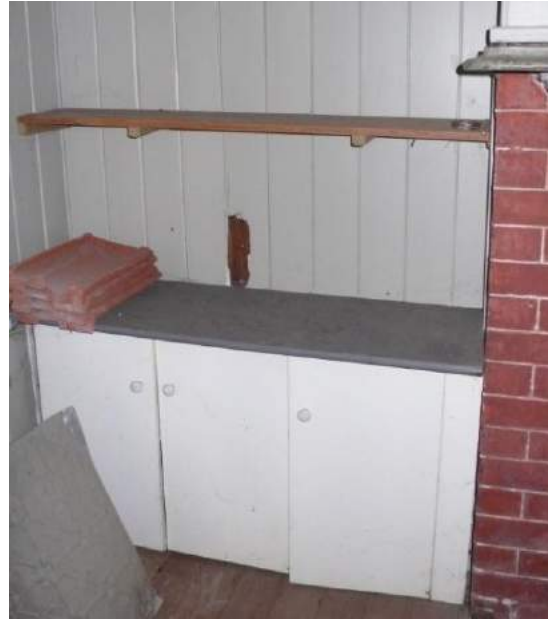
Joinery is in generally in good condition (various repairs/ replacements have been made since 1992, where it was noted that glazing bars were missing from east window and one fanlight. Sash cords were broken and the bead was missing from below the sill to the west window. (Panels were cracked on the east door)

There is a non original timber cabinet unit and wall mounted shelf fitted into the alcove to the west of the fireplace. This should be removed.

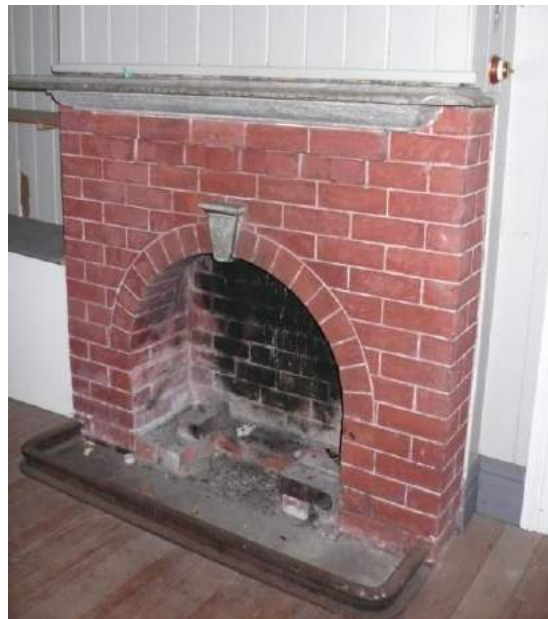
## **FIREPLACE + FIRE SURROUND**

Fireplace is in reasonable condition. Iron fire grate is missing. The corner has been broken off the concrete mantle piece. The steel railway line fireplace fender around the hearth remains in place. Gap between timber cover bead and mantle, evidence of dropping/movement.

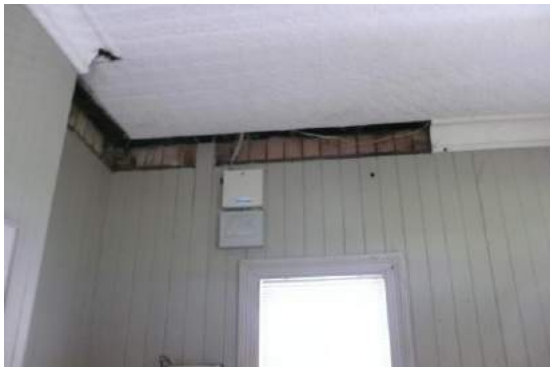
CEILING & CORNICE

Ceiling in poor condition, cornice in very poor condition missing along the entire east wall and in the south west corner.

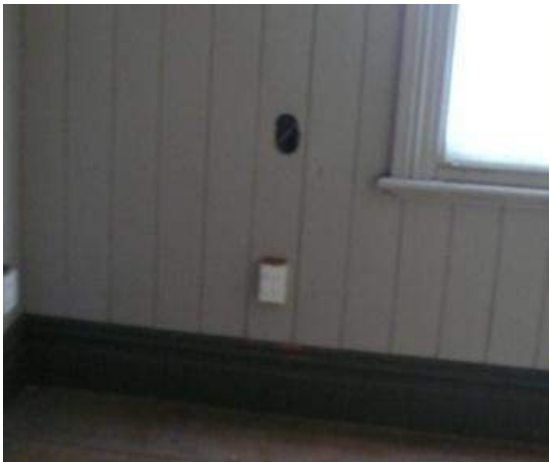
WALLS

Vertical t&g boards. Minor damage to some boards, holes and splitting. Holes in the areas where services have been re-run or fitted.

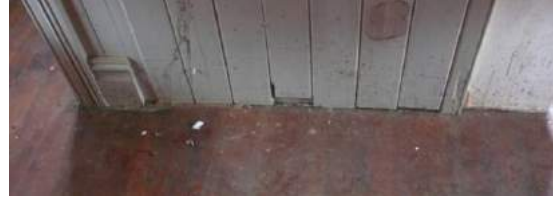
#### **SKIRTING & ARCHITRAVES**

The skirting boards have been taken off at some stage and have not been fitted back in places.

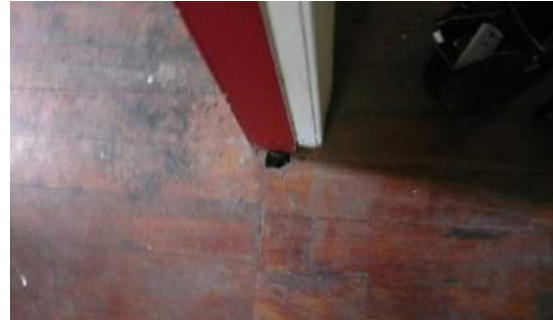
#### **FLOOR**

Refer to previous floor notes. There are some small holes in the floor.

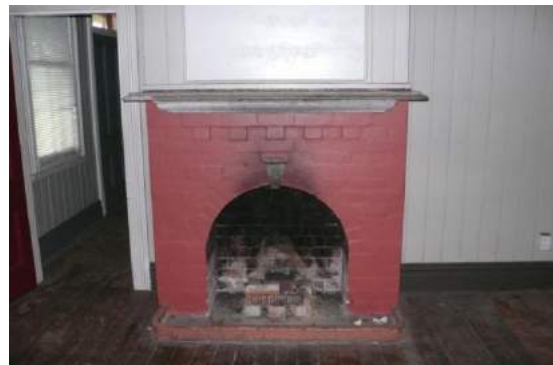
#### **FIREPLACE + FIRE SURROUND**

Fireplace is in reasonable condition. Iron fire grate is missing. The concrete mantle is in good condition. The steel railway line fireplace fender around the hearth remains in place. Gap between timber cover bead and mantle, evidence of dropping/ movement.

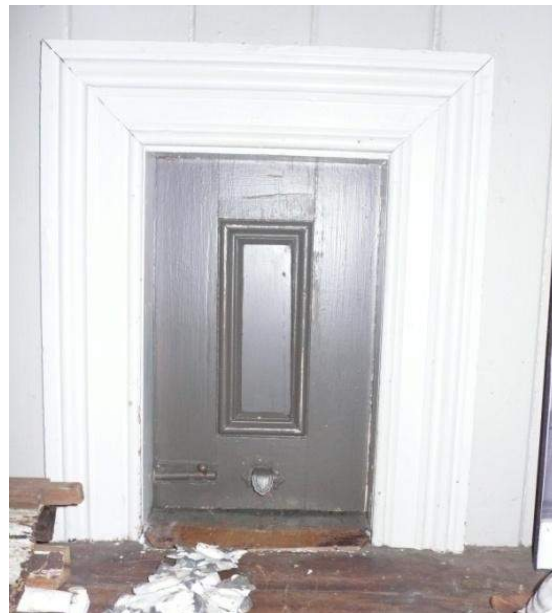
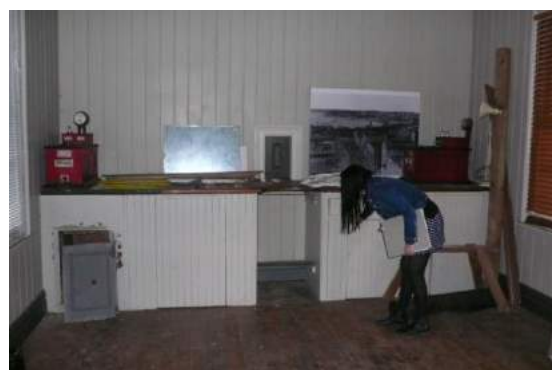
## TICKET HATCH AND COUNTER

The original ticket hatch, a vertical sliding timber panel in the wall, remains in place and is in working condition. The Kauri wall to wall counter also remains in place across the northern wall of the room. It is in good condition. To the left hand side is the original concrete encased safe within the general vertical t & g cupboard unit. The door of the safe, blown off in the 1940s, has been kept and is in the room. The cupboard and drawer unit under the bench is in two sections, split by the seating recess beneath the centred ticket hatch. This in-situ built unit has solid timber drawers and t&g cupboard doors flush with the finished surface. The entire unit is in reasonable condition, and would benefit from general repair and maintenance.

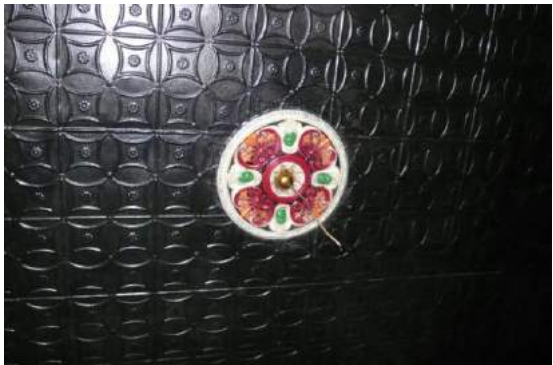
**CEILING ROSE**

Pressed metal ceiling rose in good condition. Wire but no light.

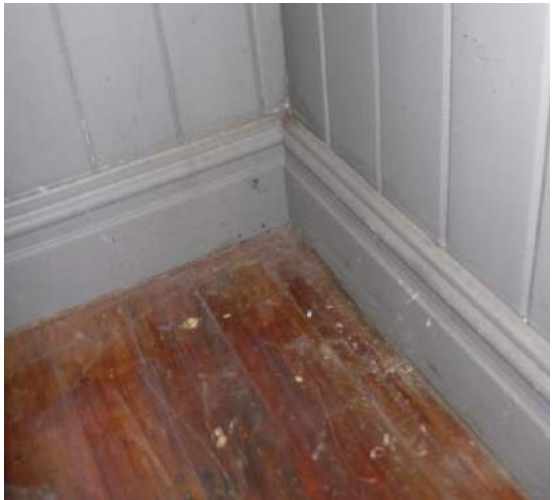
**SKIRTING & ARCHITRAVES**

The skirting boards have been taken off at some stage and have not been properly refitted.

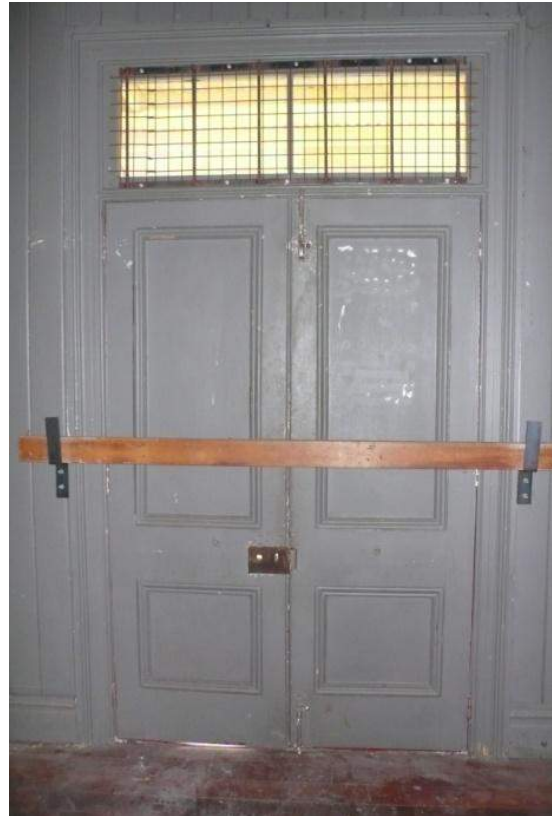
Refer to previous notes. Wire mesh security panels are fitted to the inside of all window

openings in this room. These are not original and should be removed. A metal bar on simply formed steel brackets is fitted across the double doors on the western wall.

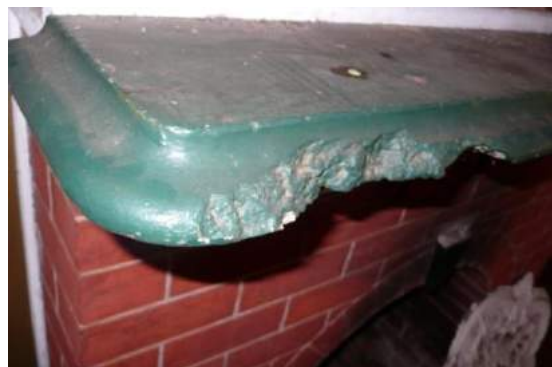
#### **FIREPLACE + FIRE SURROUND**

Fireplace is in reasonable condition. Brickwork within the hearth is missing. The concrete mantle is chipped. The steel railway line fireplace fender around the hearth remains in place. Some evidence of dropping/movement.

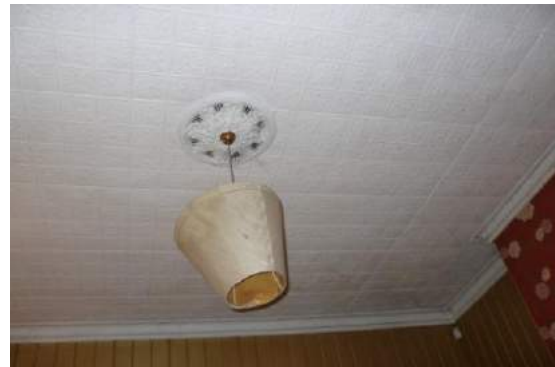
### **CEILING ROSE**

In good condition

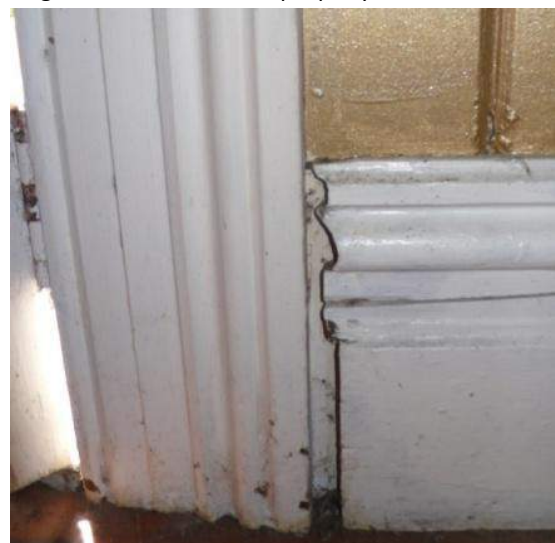
### **SKIRTING & ARCHITRAVES**

The skirting boards have been taken off at some stage and have not been properly refitted.

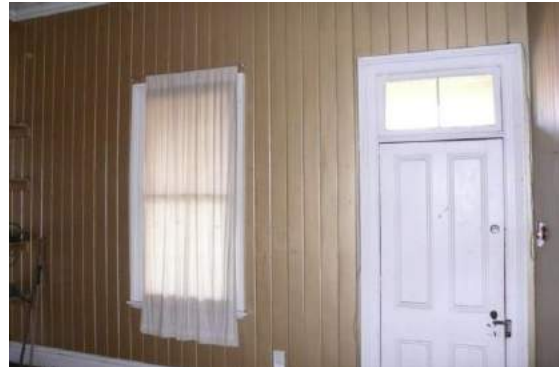
## JOINERY

Refer to previous notes. Security mesh has been fitted over the inside face of the window openings on the western side of the room.

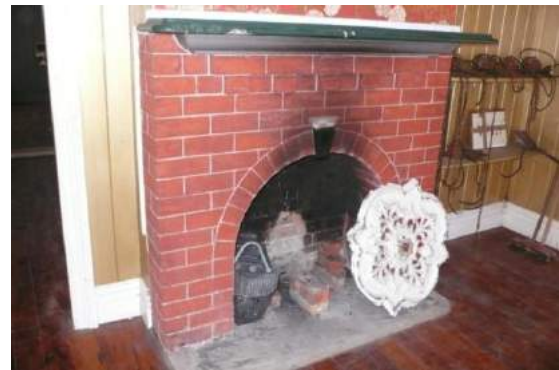
## FIREPLACE + FIRE SURROUND

Fireplace is in reasonable condition. The 'key stone' element is broken. The concrete mantle is broken at the front left edge. The steel railway line fireplace fender around the hearth is missing. Gap between timber cover bead and mantle, evidence of dropping/ movement.

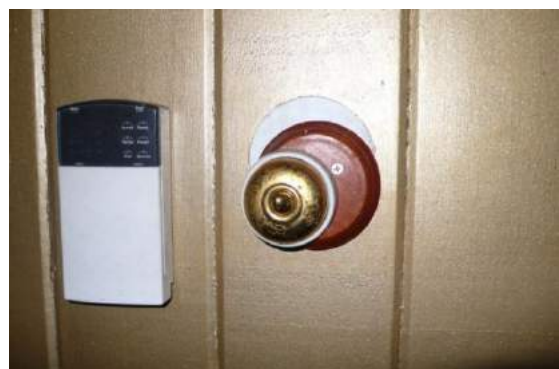
## SERVICES

New power points and switches have been fitted. Apart from the light switches, that are period styled, these elements tend to clash with the overall aesthetic of the interior. Some wiring has been run exposed. This should be concealed or removed.

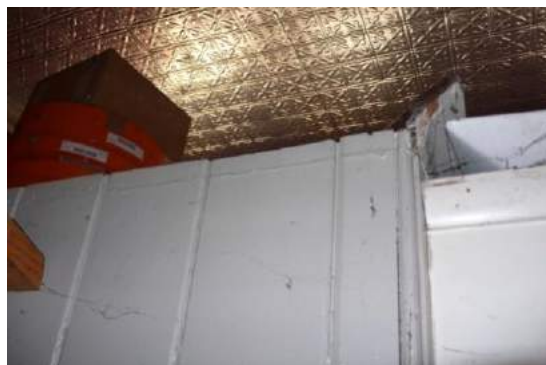
#### **CEILING & CORNICE**

Ceiling panels have been replaced using new pressed metal ceiling panels sourced by the Trust. The plain metal cornice generally in good condition with some sections rusted and in need of repair or replacement. The ceiling fitted over the toilet cubicle areas is poorly constructed and distracts from the space. This should be removed.

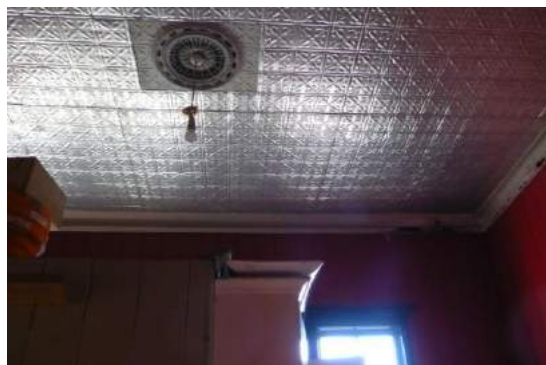
#### **CEILING ROSE**

In good condition

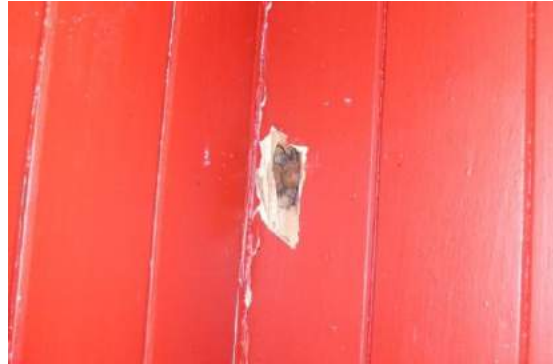
Vertical t&g boards. Minor damage to some boards, holes and splitting. Holes in the areas where services have been re-run or fitted.

A new opening has been formed in the southern wall on the eastern side of the fireplace through to the Public Lobby. The door has been removed from the doorway on the southern wall of the room, opening into the Ladies Waiting Room.

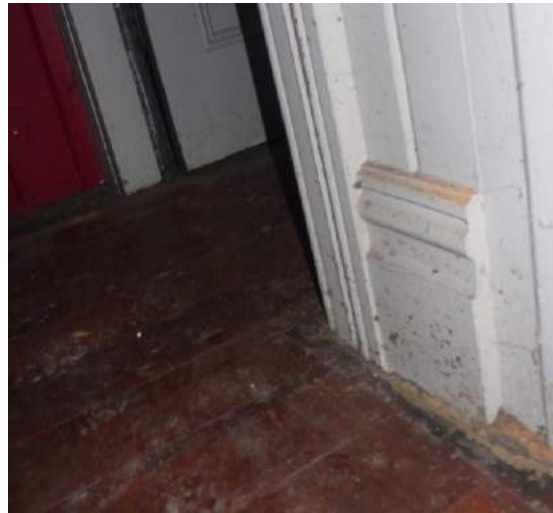
#### **SKIRTING & ARCHITRAVES**

The skirting boards have been taken off at some stage and have not been properly reinstated. Sections of the skirting remain in place under the bench.

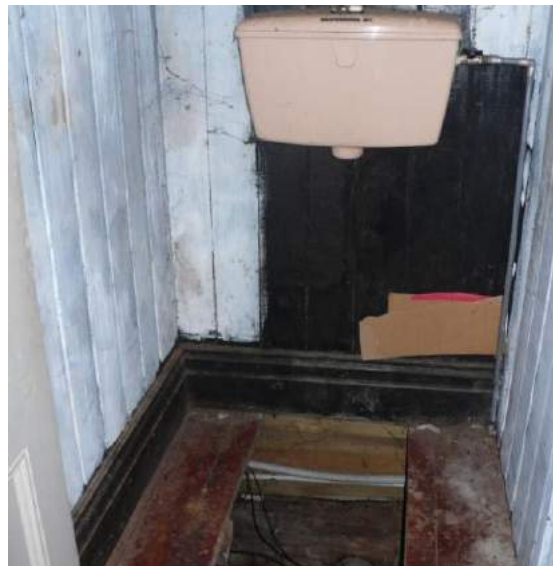
#### **FLOOR**

Refer to previous floor notes. In this area a large hole remains in the floor in the toilet area. This should be repaired and a floor access created for future repair and maintenance.

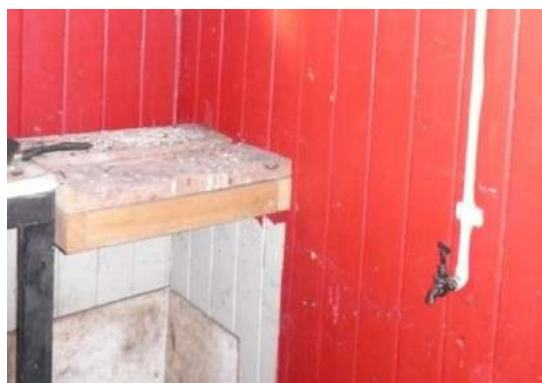
## **SERVICES**

New power points and switches have been fitted. Apart from the light switches, that are period styled, these elements tend to clash with the overall aesthetic of the interior. Exposed wires have been run through the space. These should be removed or concealed. All the new plumbing services fitted in the 1990s are prosaic and detract from the appearance of the space. There is a surface mounted period tap on the east wall. This element should be disconnected and retained.

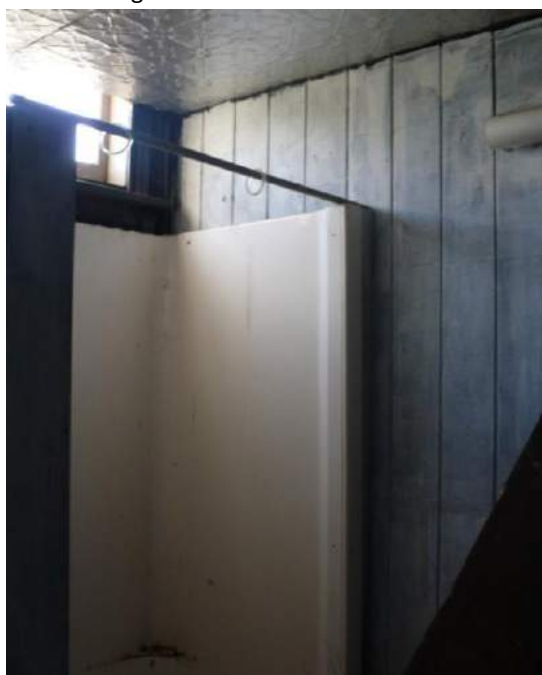
## **CUBICLES**

Vertical t & g with timber cornice and panelled doors. Sections of the cornice are missing. The openings have been altered and a ceiling constructed over part of the cubicle area. All the recent changes should be undone.

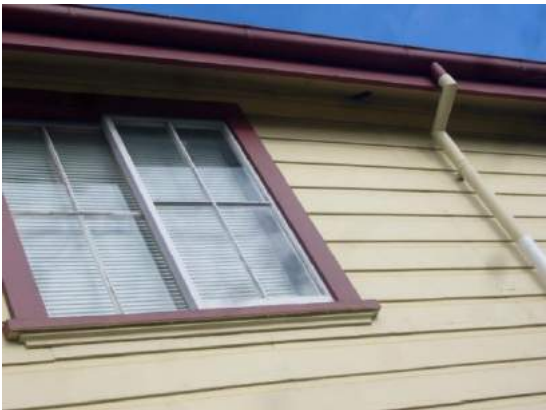
| <b>MARSEILLES TILED ROOF</b> | Reasonable condition. There is no sign of recent leakage. The roofing should be cleaned down and checked. Check all intersections in particular the ridge, the step in the gable, and the flue pipe penetration. |

| <b>SPOUTING + DOWN PIPES</b> | Clean out and check spouting and downpipes. |

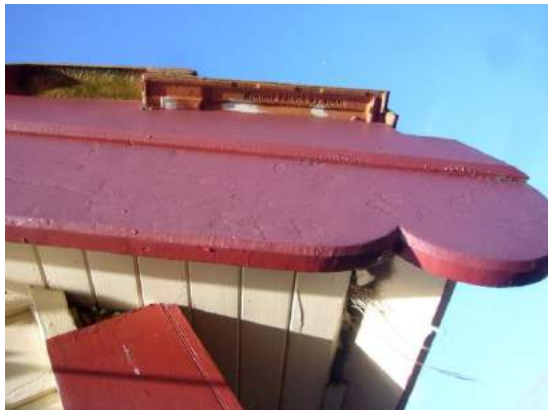
| <b>SOFFITS</b> | The soffit is narrow tongue & groove board. In several areas it is badly damaged. There is a large hole in the soffit at the north western corner of the entry porch gable. At the north west corner of the main roof the fascia is pulled away from the soffit, and nesting material has spilled out of the gap. The nesting material has been painted to match indicating that this problem is long |

standing. The soffit boards are split in places in this area.

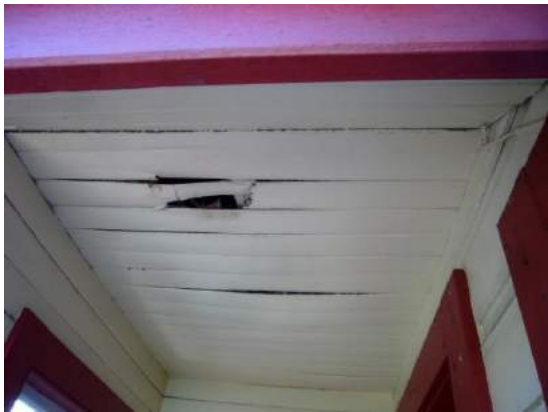
**PORCH CEILING & LININGS**

The ceiling of the entry porch is in very bad condition as a consequence of water damage. The joints have failed and there are split and broken sections.

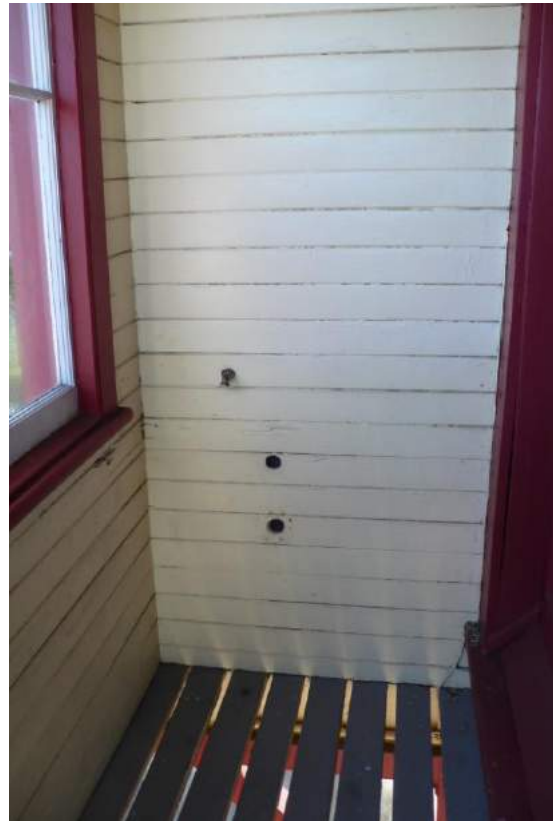
| <b><u>ELEMENT</u></b> | <b><u>CONDITION / ACTION REQUIRED</u></b> |
|---|---|
| <b>WEATHERBOARDS</b> | <p>The shiplap exterior cladding is in reasonable condition. The cladding has been repaired at the lower level. The new boards are not all in line and the junctions between the boards have been left butted. The weatherboards should match the line of the existing original. The horizontal junctions should be covered with soaker flashings or the short boards replaced with entire boards. Some weather boards are split. The split boards should be repaired or replaced.</p> <p>The lower section of the building has been re-clad and a wider base board fitted around at platform level. In this area the same problems are present in the cladding.</p> |
| <b>PORCH LINING</b> | <p>The eastern + northern ‘internal’ walls of the porch are lined in matching horizontal tongue &amp;</p> |

groove boards. The walls are in reasonable condition. There are some holes where services have been removed at the eastern end.

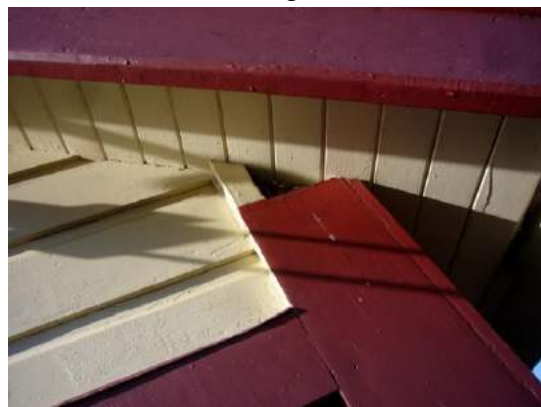
#### **FACINGS**

The facings around the joinery openings are plain flat section boards. Simple flashings are fitted over the openings. The corner facings are also plain flat section boards in a larger profile. The corner facings are cranked around the base of the cantilevered porch, framing the wall edges of the east wall and the porch itself. The corner facing at the south eastern corner is not a whole length. There appears to be a flashing over the vertical junctions. The facing board at the north west corner has a triangular gap at the intersection with the soffit. Elsewhere this gap is filled by a boxed beam end. All intersections need to be checked and made watertight.

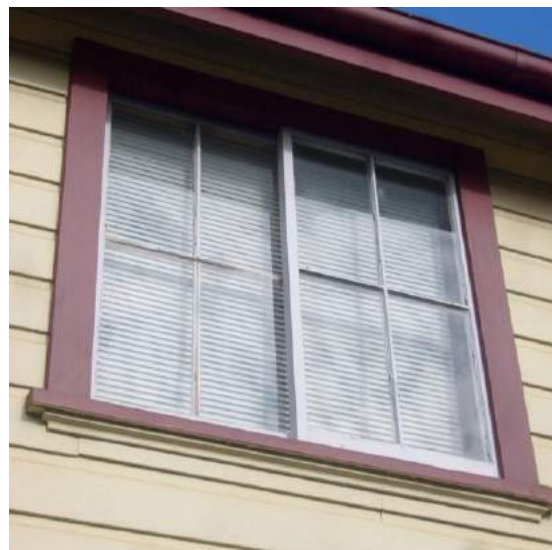
## JOINERY

At the lower level of the building there is a door beneath the cantilevered porch, two small fixed window in the eastern wall, and three fixed windows on the western wall. The door is a solid timber door made up of flat finished vertical boards. It is in good condition. The windows are also in good condition.

The northern wall of the porch has a four paned fixed window. This window is in reasonable condition.

The door into the signal box is a four panelled inward opening door. The panels are sunk solid timber with bolelection mouldings. The base of the door has an angled drip moulding to weather the cill. This door is also in reasonable condition.

The window joinery of the signal room on the upper floor consists primarily of sets of fine sliding paired sash units. There is a single unit centred on the east wall, two sets of uneven sash units facing south the full width of the wall, three joinery units the full width of the west wall, sliding units at each end with a fixed sash between, and a single unit, in three parts, at the western corner of the northern wall. These units appear to have been repaired, and are in good condition. The cills of these units project further out from the face of the cladding than the standard windows. The cills are supported by a coved timber bead.

Check all joinery at regular intervals to ensure condition and ease of movement.

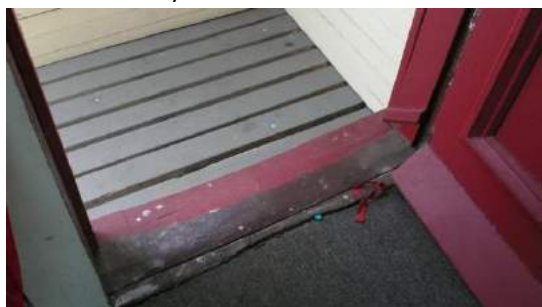
#### **ENTRY PLATFORM**

The entry platform is an open deck supported by triangular framed timber brackets at each end and at the centre. The stair stringers also provide support to the exposed deck framing. The eastern corner of the entry platform is semi-enclosed by the small projecting gable/porch that gives cover to the doorway. The exterior finishes of the porch are as previously described under, roof, cladding, joinery & porch lining. The decking is open slat decking and appears to be new. The handrail follows the detail and profile of the stair handrail. In addition to the post and handrail there are diagonal crossed rails within the handrail panels on each side. The handrail has pulled away from the building at the North West corner, indicating that the original alignment of the deck and main building is out of line. Public safety is a concern as the stair is easily accessed.

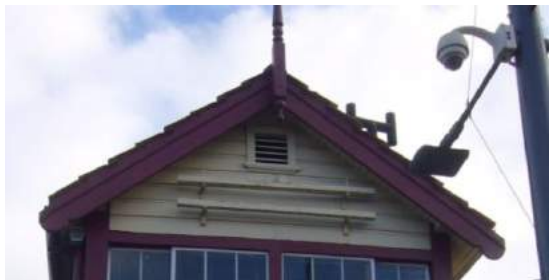
**LOUVRE PANELS IN GABLE ENDS**

At each end of the main gable at the top of the wall is a square louvred opening. The louvres are horizontal fixed timber boards in a frame with full cill and facings. The cill is supported by a coved moulding. These should be checked, and if necessary, made bird and insect proof.

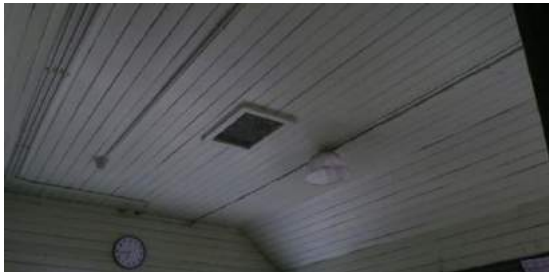
**CEILING LINING**

strip timber t & g lining running the length of the room, with a single framed metal ceiling vent. Surface fixed conduit. Ceiling linings are generally in good condition. All original conduiting should be retained, all recent conduit should be removed.

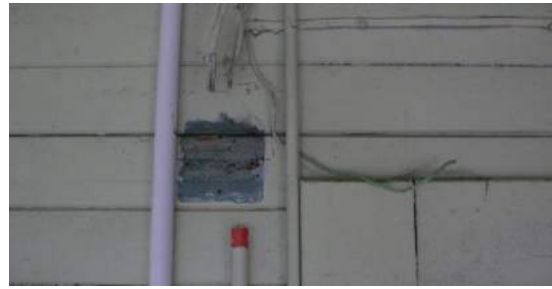
**WALLS LINING**

Matching horizontal strip timber lining. Generally in good condition. Some minor holes where services penetrate or have been removed. Remove redundant services. Repair to match.

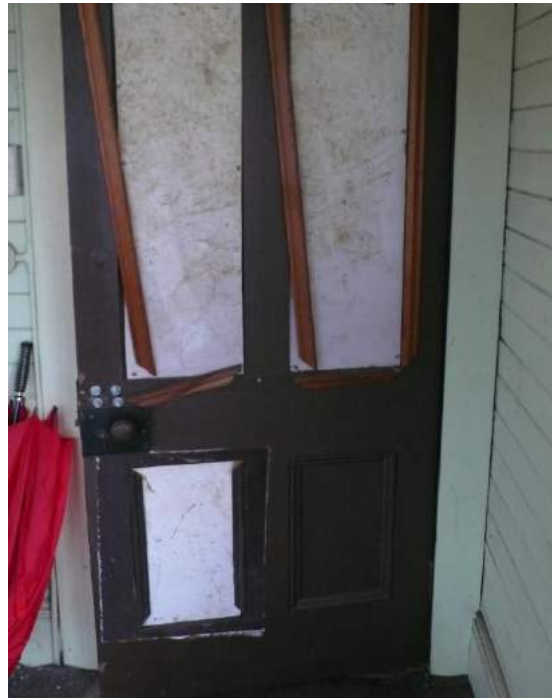
**DOOR**

The inside face of the door is in very poor condition. Most of the mouldings are loose or broken, and the panels appear to be temporary replacement panels. The door stop is a planted piece of wood.

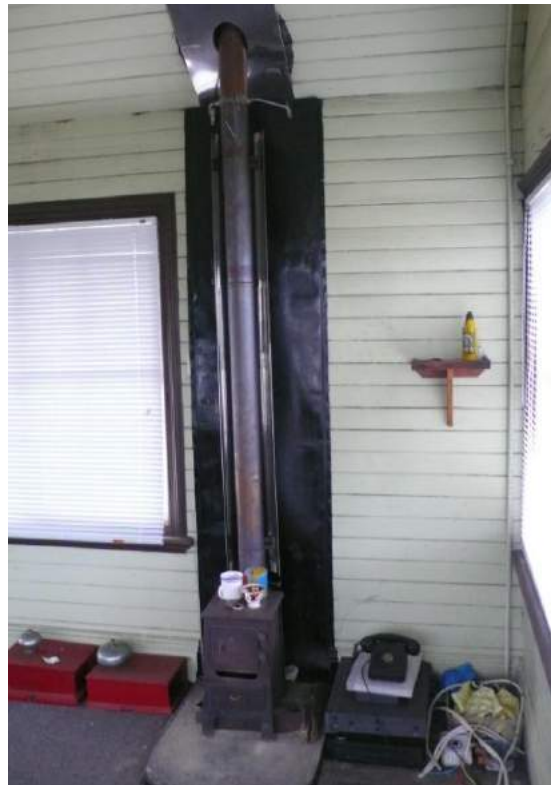
## STOVE

The original wood burning stove unit has been removed. A replacement unit has been installed by the Trust. The fire was a free standing small 'pot belly'. The replacement is similar in size and form. The concrete base remains. The heat shield flashing to the wall appears to be a replacement. The Heat shield flashing to the ceiling is new as the trace of the former circular plate remains on the ceiling. The fire area is in good condition. The fire is not used.
