# **REMUERA**

## **RAILWAY STATION + SIGNAL BOX**

57-58 Market Rd/122 Great South Rd, Remuera

## **CONSERVATION PLAN**

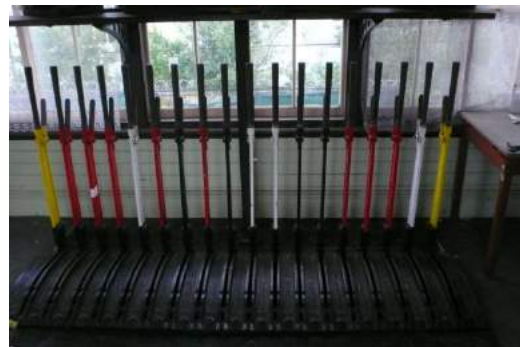
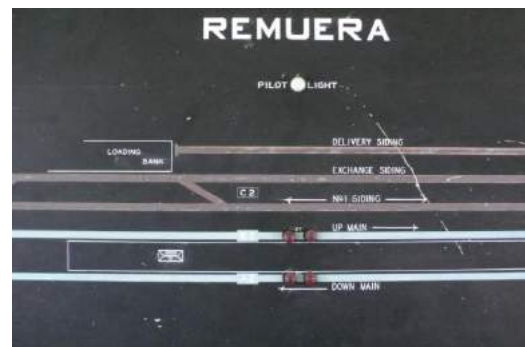
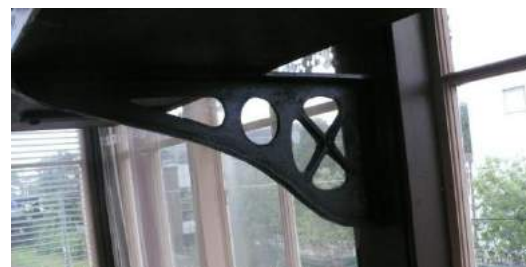
## EQUIPMENT

The signal equipment remains in the room. This unit runs across the west side of the room. A slab timber bench supports the signal panel and associated electrical equipment. This is supported on cast iron brackets. In front of the bench is an array of levers fitted into a floor panel. The equipment is no longer used. As artifacts related to the history of the station and the rail network this equipment is of tremendous value. Some of the glassware covering the signals equipment is missing. These missing elements should be re-instated.

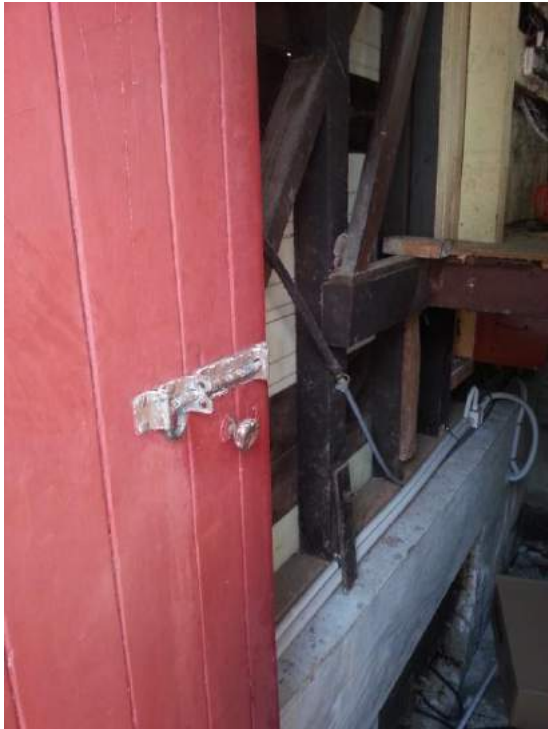
| <b>ENTRY DOOR &amp; PLATFORM</b> | The entry door is set on the concrete base of the building. The base has been raised as part of the lifting works. The platform remains at the lower level, making this a dangerous threshold. If the area is to be used in future a new platform will have to be constructed and the access restored to the working platform and possibly closed to the sub-floor area. |

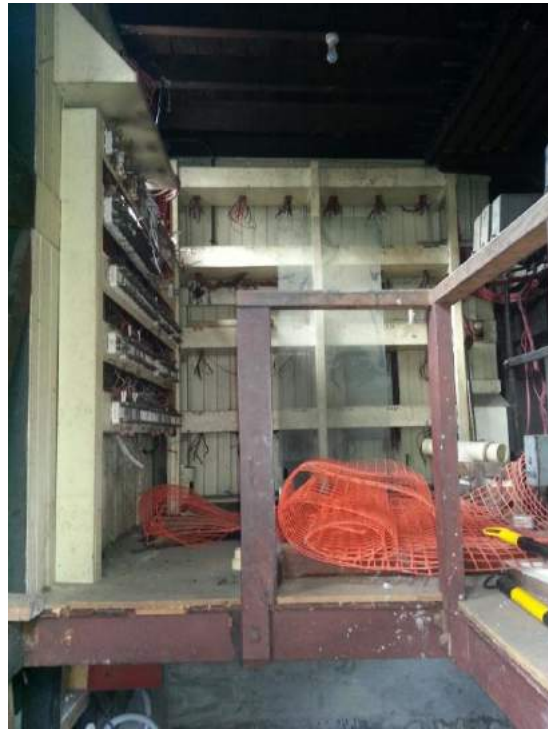
| <b>WALL FRAMING</b> | The interior walls are unlined. The full structure of the building is visible. There are heavy beams each side of the lever unit and across the northern wall to provide support for the deck brackets. The framing appears to be in very good condition. |

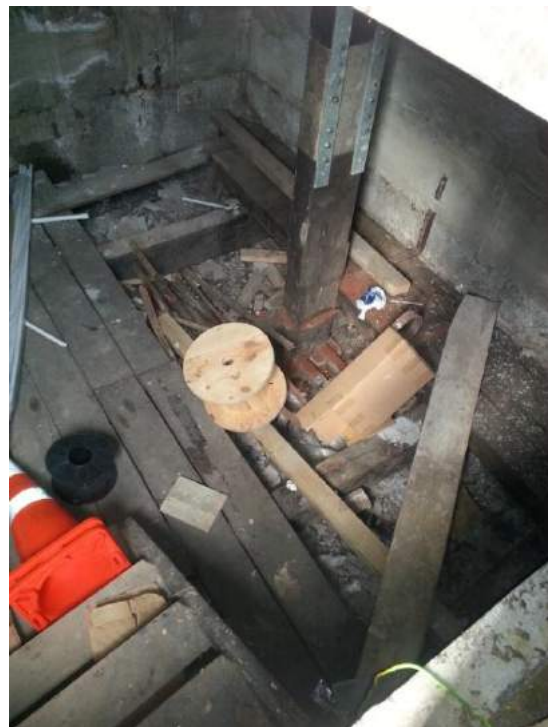
#### **SUBFLOOR FRAMING**

The entire base of the building has a concrete foundation wall. The subfloor wall and framing are in very good condition. There is some rubbish in the area. This should be removed.
